ASME PVP2014-28476

Nuclear Power Plant Issues in IAEA Draft Technical Guidelines on Fluid-Structure Interactions

2014/07/22

Hitachi, Ltd.

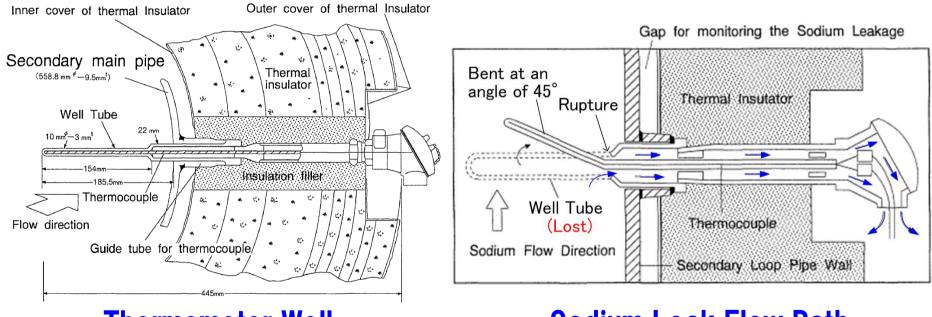
3 Failure of Monju Thermometer Well (1)

A sodium leakage incident occurred due to breakage of a thermometer well in Monju.

Thermometer Well

Sodium Leak Flow Path

Avoiding self-excited vibration is important for guidelines.

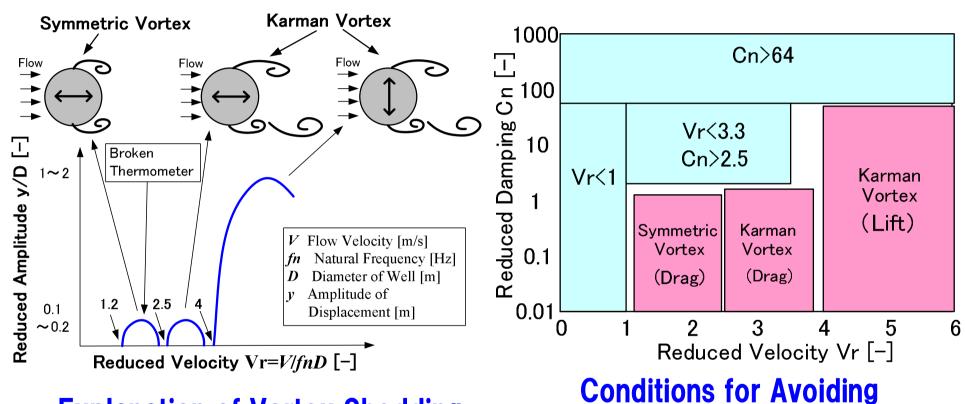
Explanation of Vortex Shedding

Lock-in Synchronization

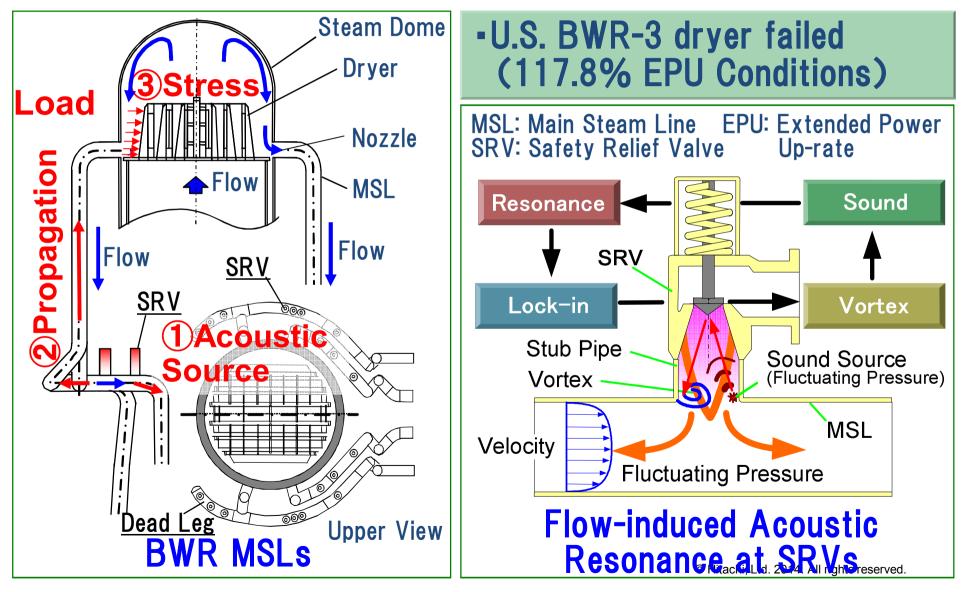
5 Dryer Failure at Quad Cites Unit 2 (1)

Cause of dryer failure was fluctuating pressure at SRVs.

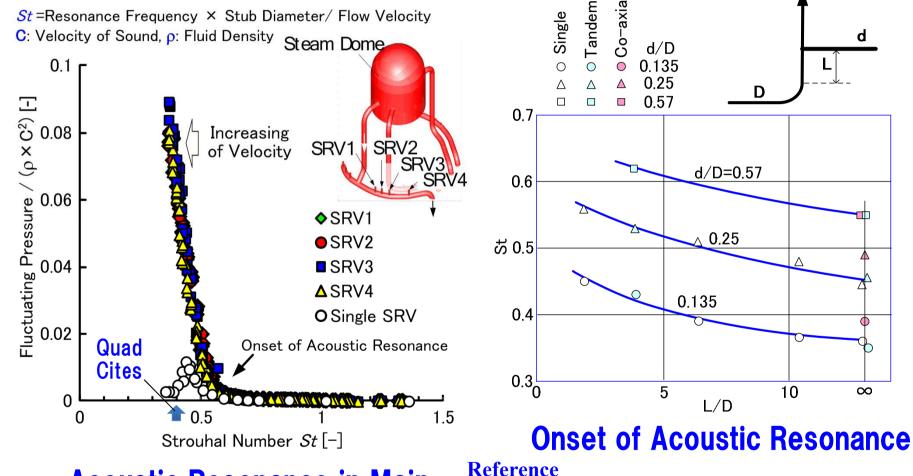
Acoustic Resonance in Main Steam Line & Dryer (Air Test)

Evaluation of acoustic resonance is included in guidelines.

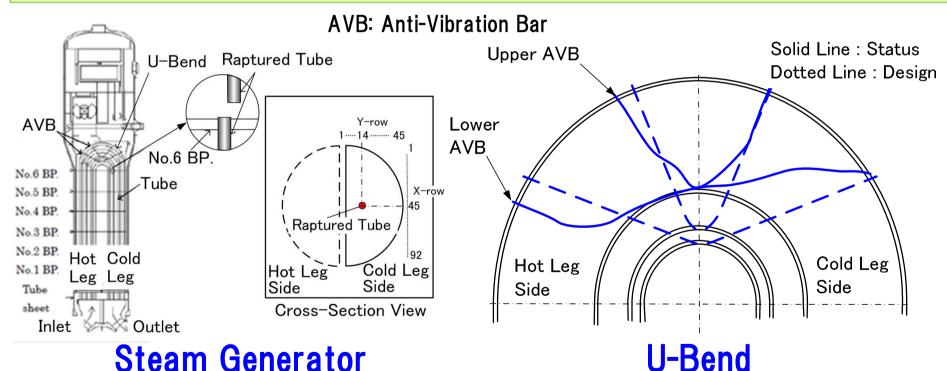
7 Steam Generator Tube Failure at Mihama (1)

Main cause of SG failure was fluid elastic vibration.

- Leakage from steam generator in Mihama Unit-2 in Japan.
- A tube was broken at the bottom of the upper U-bend.
- The tube had not been supported at the U-bend with an AVB.

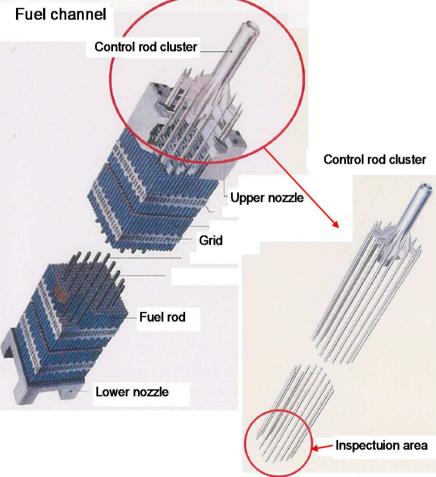
12 Plant Issues (1) Control Rod Cluster

Tip of the CR cluster contacted with CR guide tube by small vibration due to water flow.

Fuel channel
Components	Control rod (CR) cluster in	Co
•	fuel channel.	_
Plant	Genkai-4 (PWR)	
Date	September 19, 2010	
Plant	Periodic in-service	3
condition	inspection	
Event	Wear at the tip of the	
Lvent	control rod cluster	
Reference	NUCIA, 2010-Kyusyu-	
Relefence	M001 Rev. 1	Lov

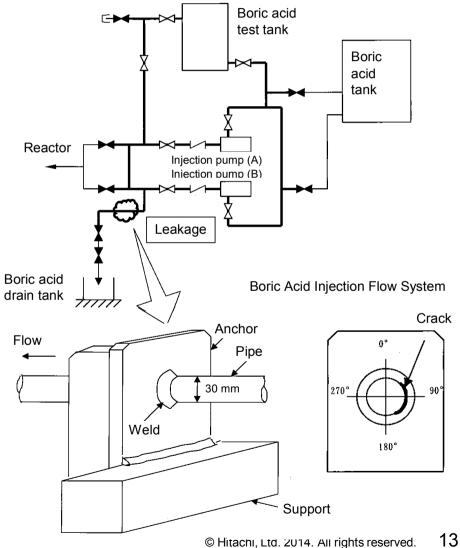
13 Plant Issues (2) Pump and Piping System

The drain pipe was vibrated by pulse pressure and pump body motion.

Component	Drain pipe for boric acid injection system
Plant	Kashiwazaki-Kariwa -1 (BWR)
Date	September 30, 2003
Plant condition	Periodic in-service inspection
Event	Leakage at welded joint of boric acid drain pipe
Reference	NUCIA, 2003-Tokyo- M020
